Experimental investigation on the seismic isolation for a legged wine storage tank

J.I. Colombo ^{*}, J.L. Almazán

Department of Structural and Geotechnical Engineering, Pontificia Universidad Católica de Chile, Vicuña Mackenna 4860, Santiago, Chile

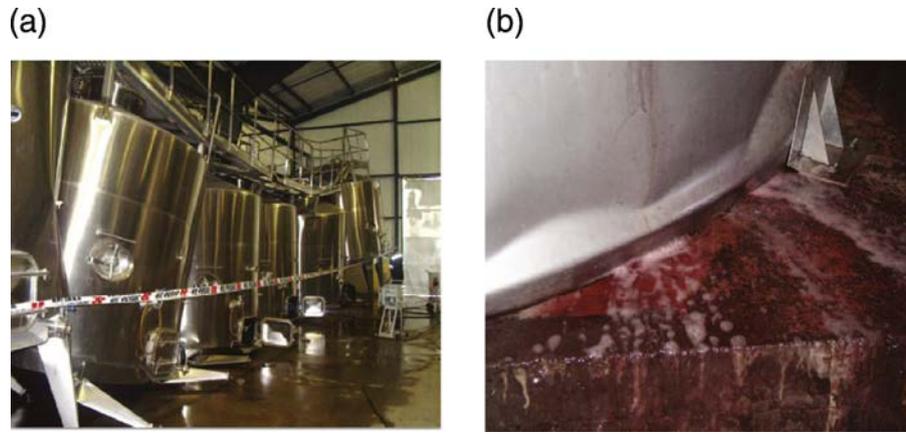
Fig. 1. Typical failures in steel wine storage tanks that imply loss of the liquid content: (a) buckling of the tank legs and (b) rupture of the shell-base connection.

in liquid storage tanks are: damage to the piping connections caused by large base uplifts, damage to the roof caused by the sloshing of the free liquid surface, buckling of the tank walls caused by the high compressive stress, buckling of the tank legs caused by large axial loads coupled with lateral loads, failure of the anchorage system caused by the high overturning moment transmitted to the base, penetration of the tank wall with anchor bolts caused by the previous failure of the anchorage system and damage to the shell-base connection caused by the plastic rotation of the base plate. Among these causes, the failures that are responsible for a large or total loss of the liquids contained in storage tanks are buckling of the tank legs and rupture of the shell-base connection (see Fig. 1).

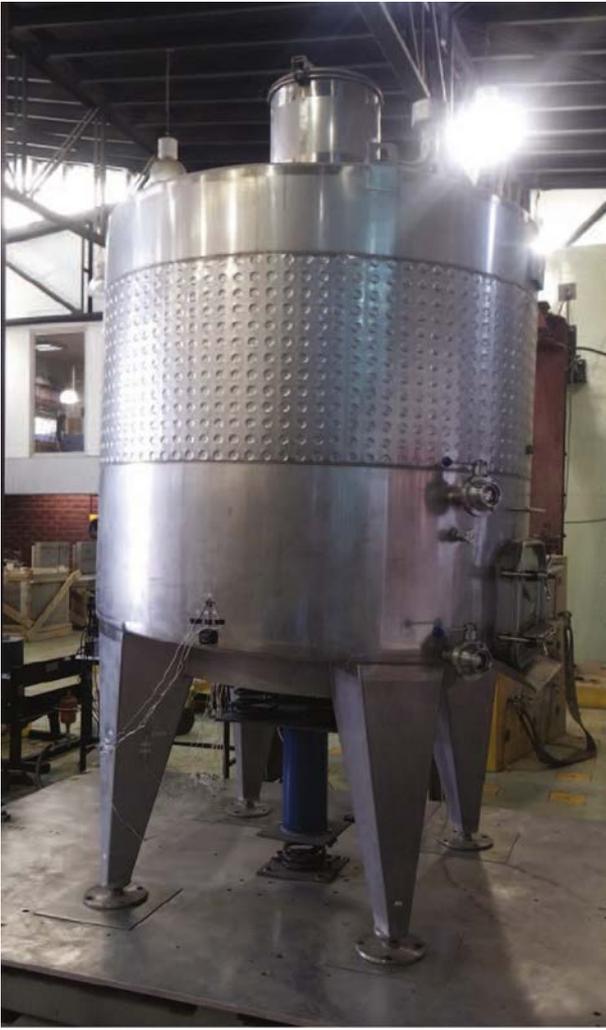
Fig. 3. Legged wine storage tank utilized in the experiments.

Experimental tests were carried out on a full-scale stainless steel legged tank which is typically used for fermentation and wine storage (see Fig. 3). When subjected to a strong seismic ground motion the structure may undergo several failure modes. The most significant failure modes are: buckling of the tank legs and failure of the anchorage bolts at the legs. Therefore, the purpose of this research is to avoid such failures modes using a new device for seismic isolation.

The dimensions of the tank are: radius $R = 0.8$ m, wall height $H_w = 1.70$ m, and length of the legs $L_g = 0.9$ m. The wall, base and legs are realized with stainless steel plates having a thickness of 2 mm. The tank is supported on four legs with upper width $w_u = 22$ cm, and lower width
